THE POTENTIAL FOR RESTORATION ALONG THE VIRGIN RIVER IN ZION NATIONAL PARK

FINAL REPORT

**THE POTENTIAL FOR RESTORATION
ALONG THE VIRGIN RIVER
IN ZION NATIONAL PARK**

September 2001

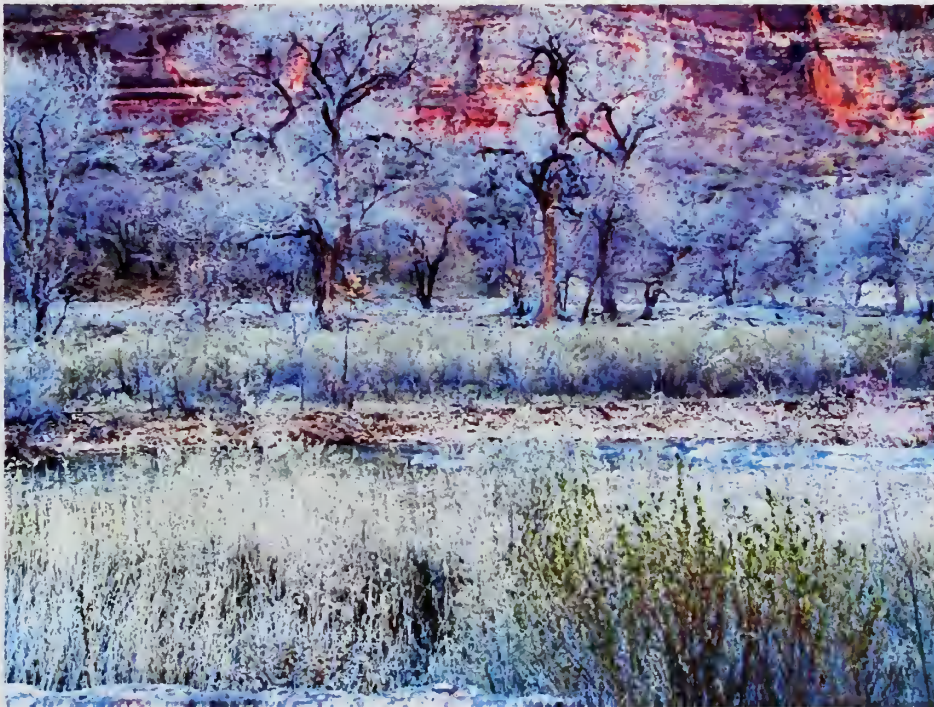
FIGURE 1. Mature cottonwood trees in Zion Canyon are nearing the end of their biological life. Lack of suitable conditions limits the recruitment of young cottonwoods to take their place. Note lack of young or middle age trees.

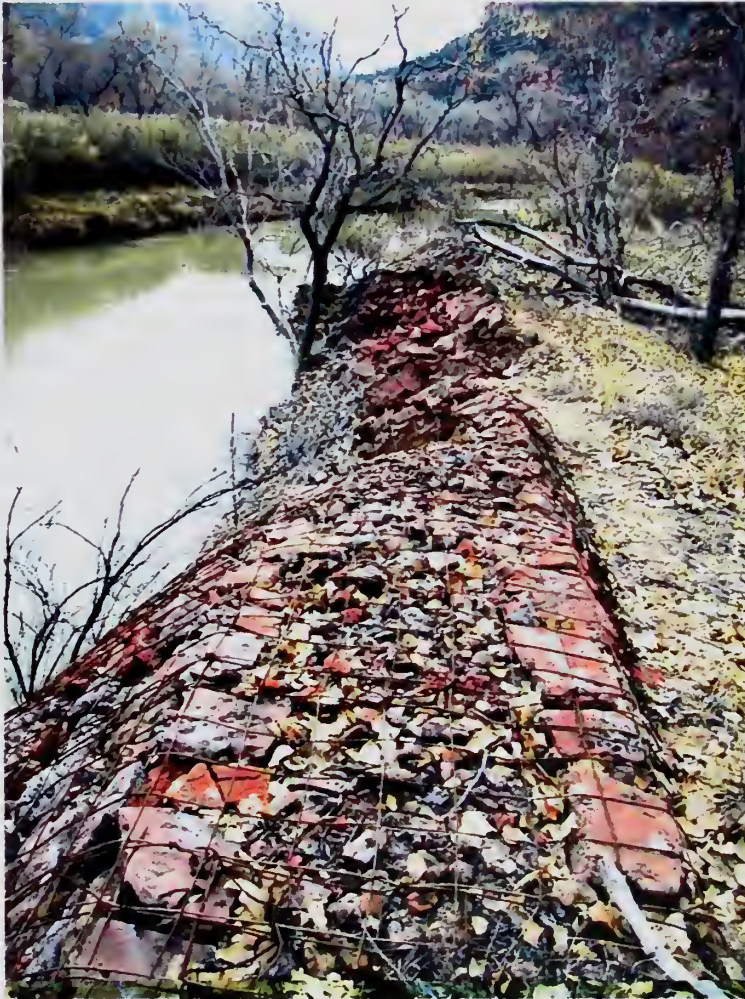
FIGURE 2. Rock and wire revetments channelize the Virgin River in Zion National Park.

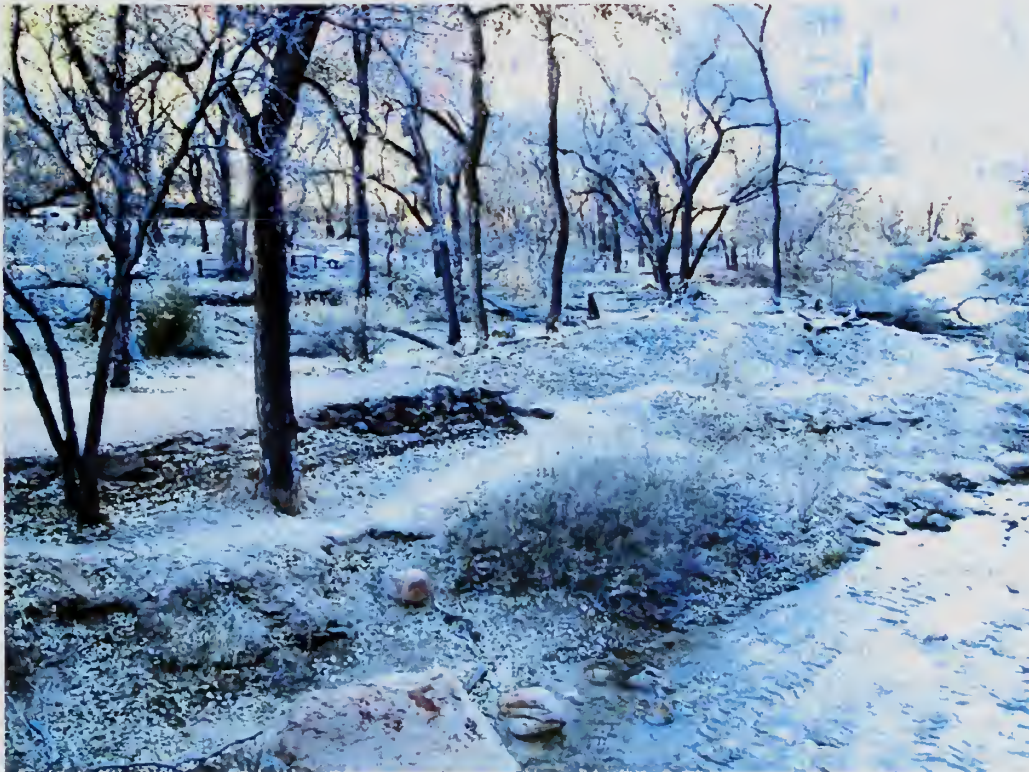
FIGURE 5. Lack of young cottonwood trees along valley floor in Zion Canyon. These areas now lie more than 12 feet above the river and no longer contain conditions favorable to cottonwood recruitment.

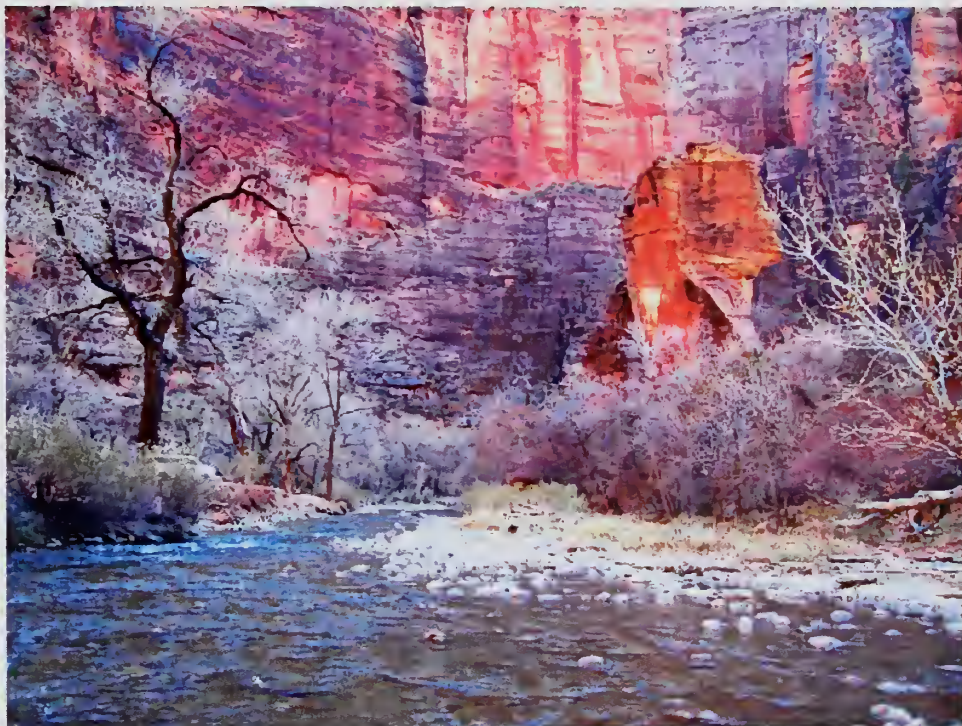
Figure 7b. Narrows site. Parking area on left and geologic control on right constrain stream channels ability to spread across a floodplain.

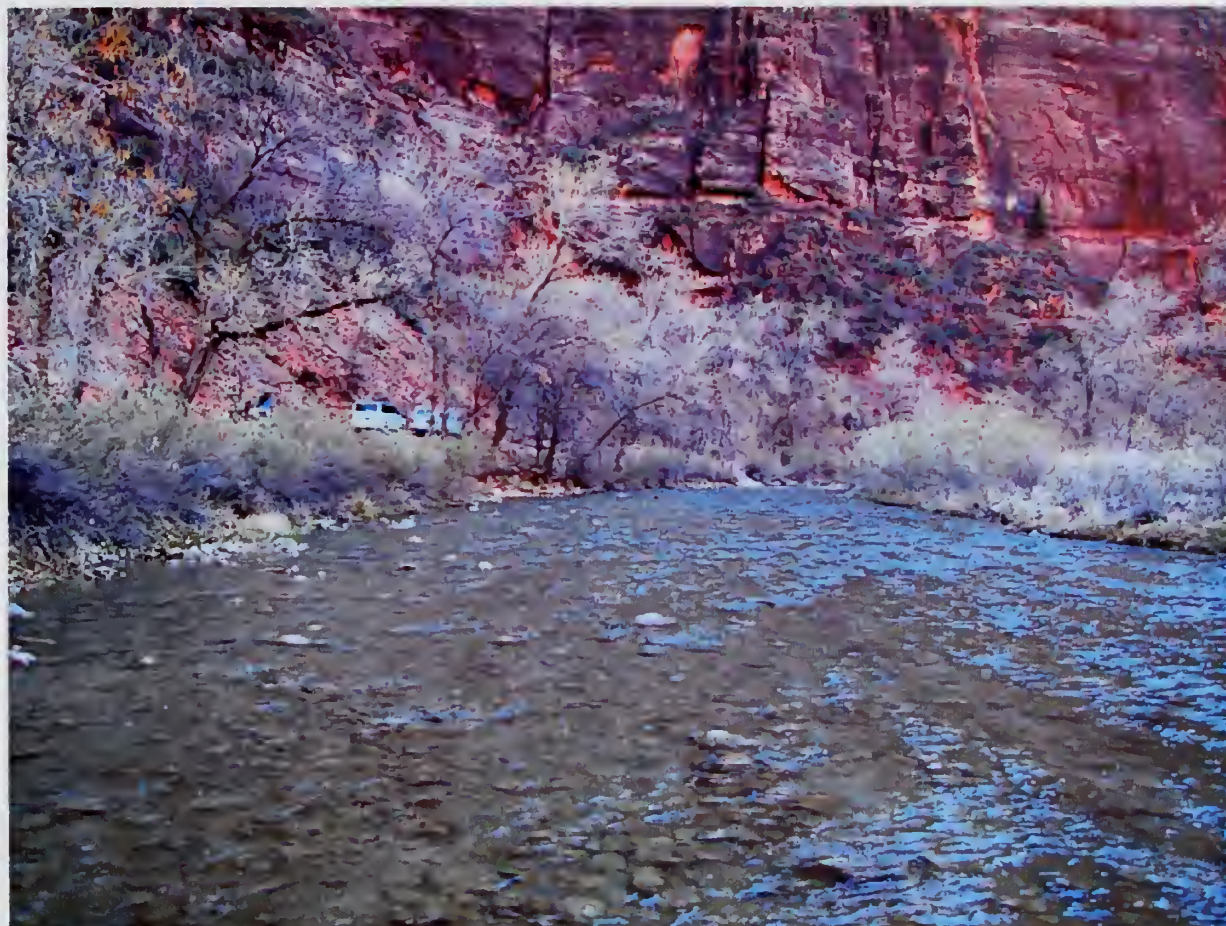
FIGURE 8b. Hereford Site. Stream channel is constrained by roadway on river left and well-vegetated low terraces along river right. Note dense vegetation along both banks and absence of disturbed soils suitable for cottonwood recruitment. Whether mature cottonwoods along road were the result of natural recruitment or planting is unknown.

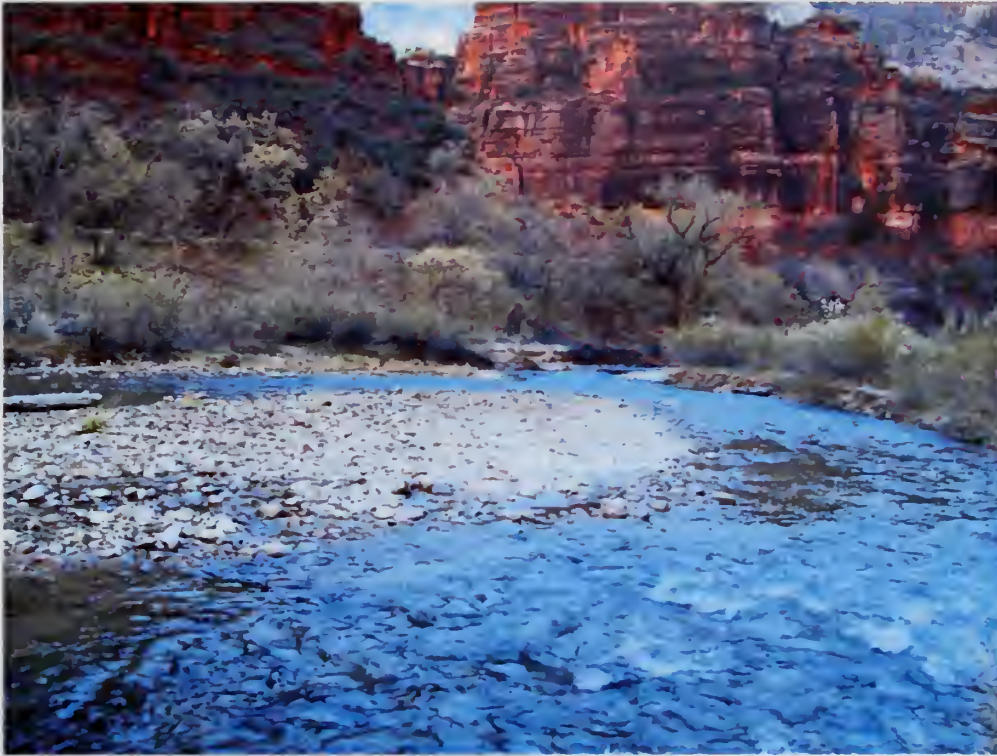
FIGURE 9a. Photo of Big Bend survey site. Note active deposition in central channel bar and low floodplain features along both banks. Numerous young cottonwood, ash, and box elder trees were found in floodplain and cutoff channel areas.

There are several 10 - 20 feet tall ash and cottonwood trees established within the floodplains or in the abandoned or cutoff channels. Ash are usually more common. Hundreds of small seedlings (ash and cottonwood) were observed on low, moist sandbars located within the bankfull channel. However these have very little chance for survival. *Baccharis* dominated the low terraces or floodplains but willow as well as tamarisk was much more common in this reach. Several Cottonwood individuals 10 – 20 feet tall were observed along the floodplain and in abandoned channels.

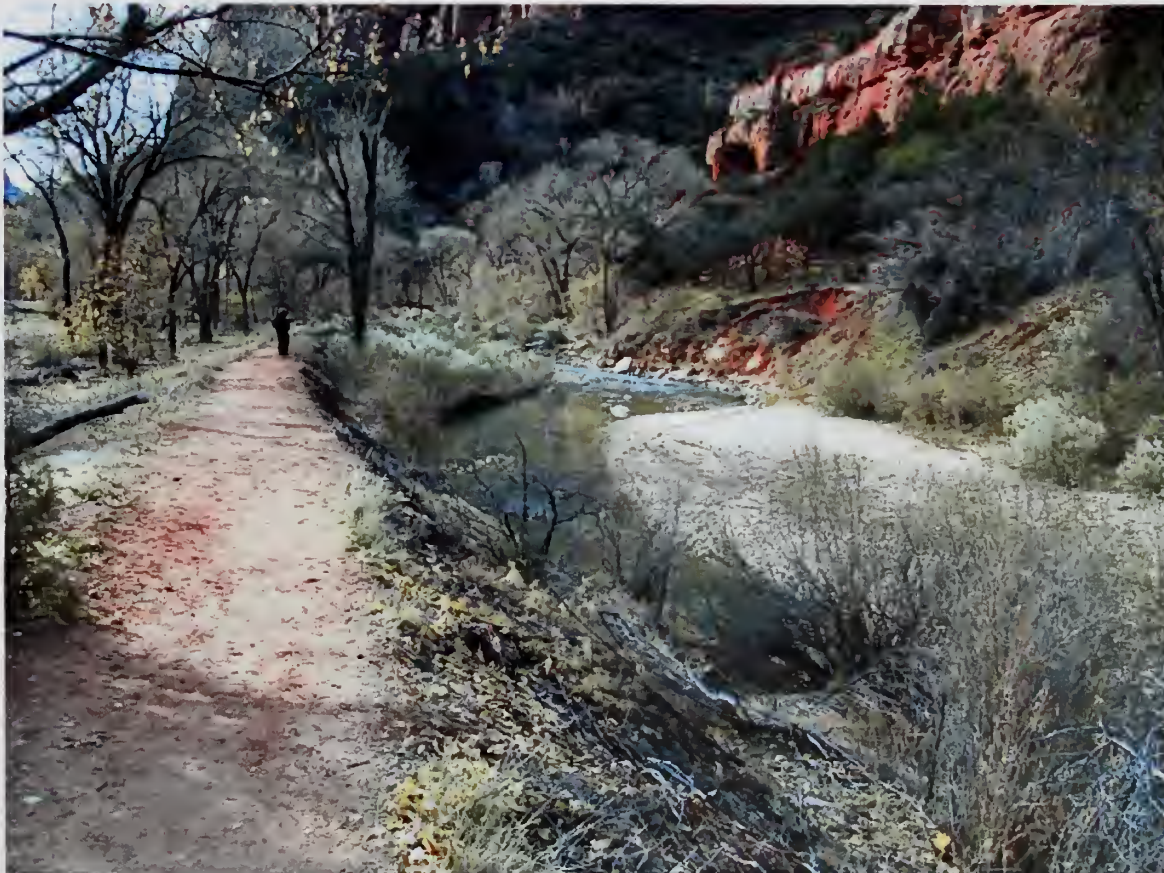
The reach is stable in that there are no cutbanks, however it is deeply incised below high terrace. Both banks thickly vegetated primarily with *Baccharis emoryi* with a few *Salix exigua* and tamarisk. A sedge/rush community exists along water's edge. Cottonwood seedlings are numerous on very low bars well below bankfull but are unlikely to survive subsequent flows. Scattered juniper grow at the elevation of the right cross-section marker pin on upland slope. No riparian tree species were observed along either bank.

FIGURE 11b. Photo of Grotto footbridge site. Channel is severely channelized by rock and wire revetment on river left and by canyon walls on river right. Lack of floodplain features limits riparian vegetation including cottonwoods.

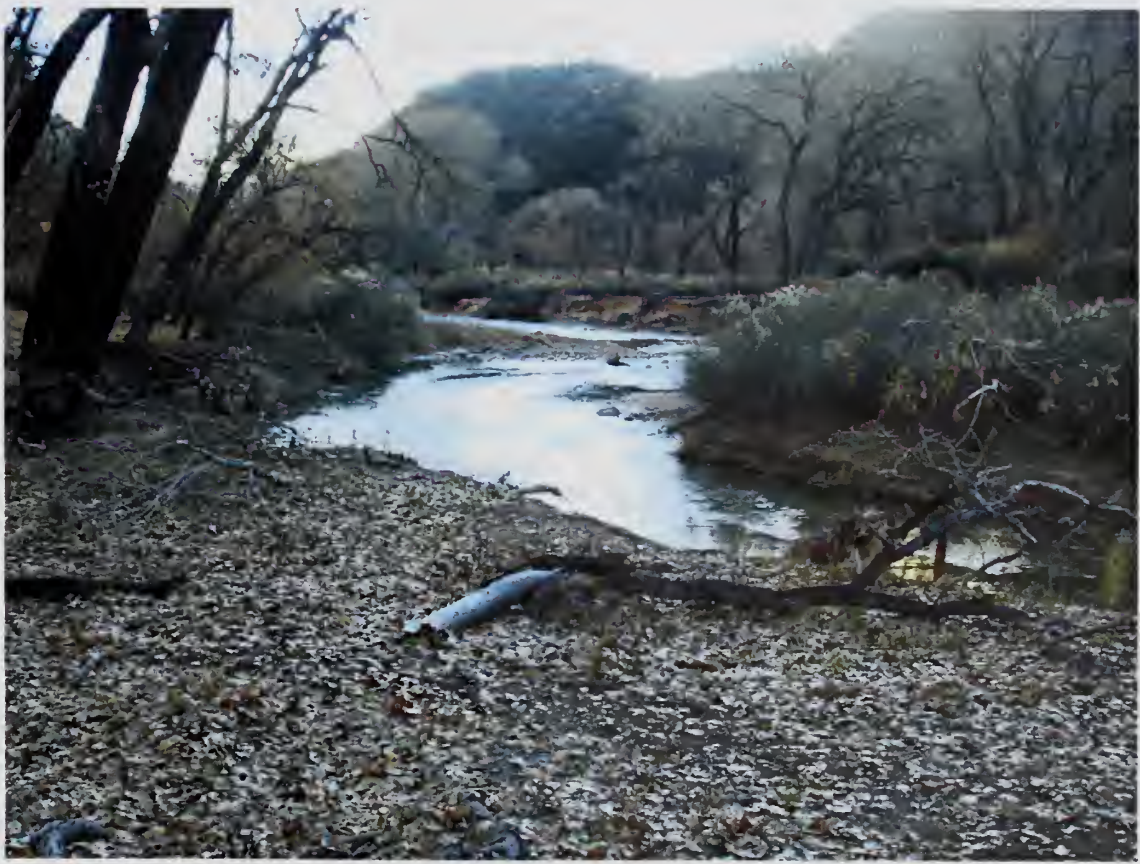
The high point bars are dominated by *Baccharis emoryi*. Some *Salix exigua* is present along the outer faces of these point bars. No cottonwood sprouts or young trees were observed within the reach. Mature cottonwoods and other trees are limited to the upper terraces. A topographic survey was completed on the Zion Lodge and Birch Creek reaches and two representative cross-sections were created.

FIGURE 12a. Photo of Birch Creek site. Stream channel is constrained by high terraces along both banks. Mature cottonwoods and grasses cover high terraces.

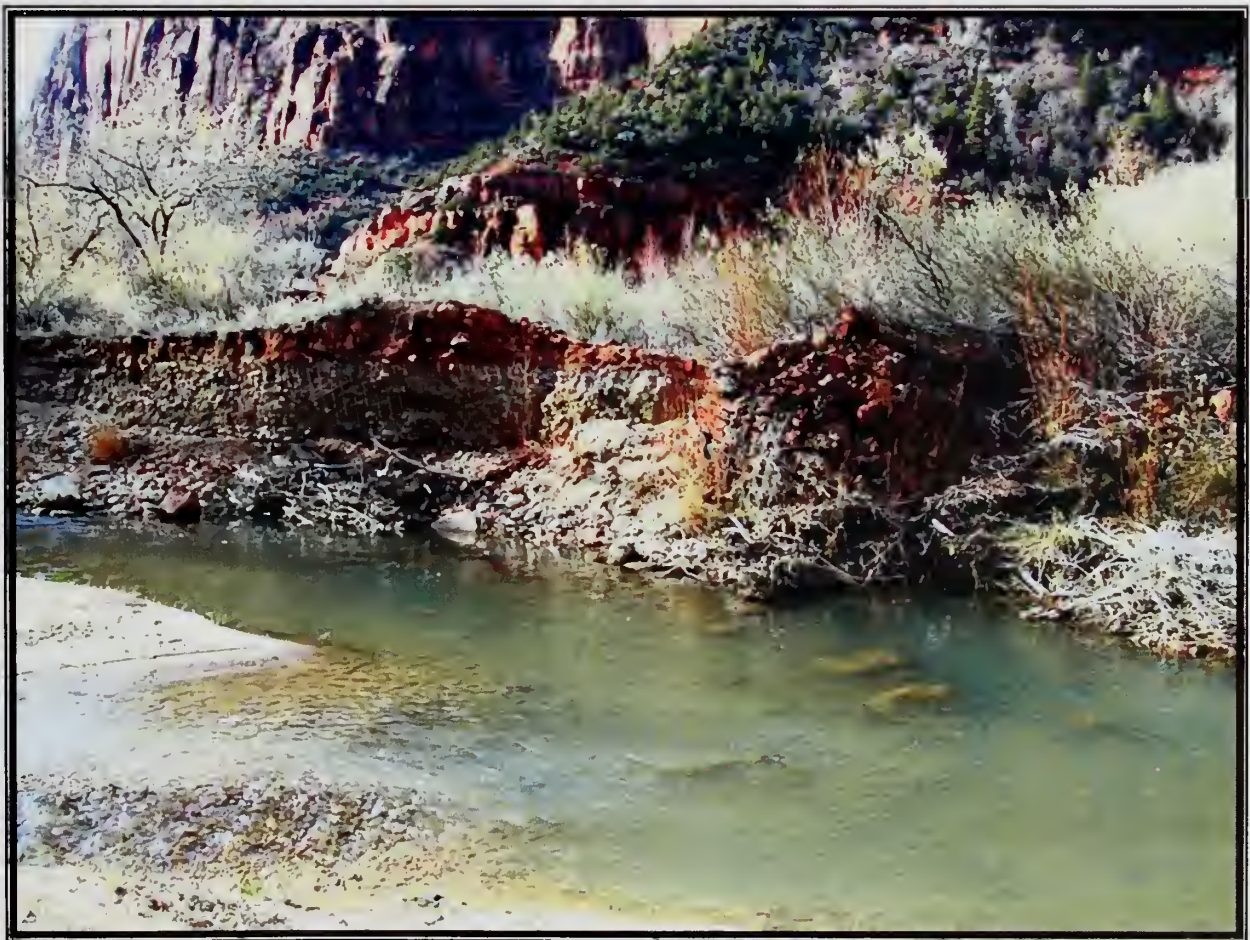
The location, volume of material, and condition of the revetments in the reaches below the Grotto footbridge were documented for this project. In general, the revetments are constructed of relatively small rock rip-rap (6 – 16 inches) and covered with heavy wire. The gabions line the east bank almost continuously from above the Grotto footbridge to well below the Zion Lodge. The revetments are from 6 – 12 feet in height and 4 – 8 feet thick. They contain an estimated 90,000 square feet of wire and 8,500 cubic yards of rock.

FIGURE 20. Rock revetments in disrepair near Zion Lodge
