THE POTENTIAL FOR RESTORATION ALONG THE VIRGIN RIVER IN ZION NATIONAL PARK

FINAL REPORT

**THE POTENTIAL FOR RESTORATION
ALONG THE VIRGIN RIVER
IN ZION NATIONAL PARK**

September 2001

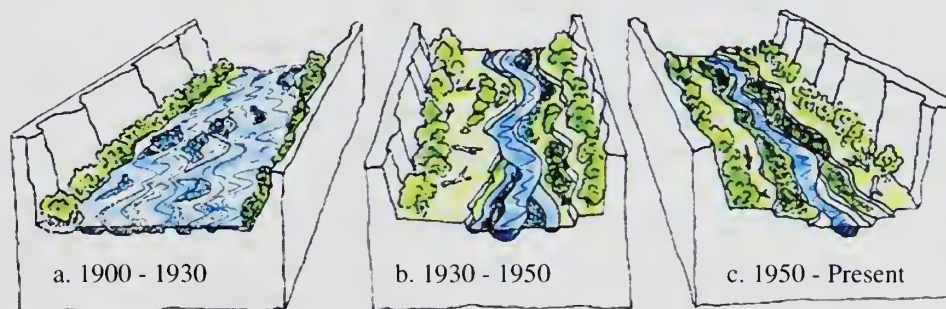
FIGURE 3. Geomorphic evolution of the Virgin River. Changes in climate and watershed condition resulted in the evolution from a wide braided channel to the current narrower channel. Man-made revetments exacerbated the process.

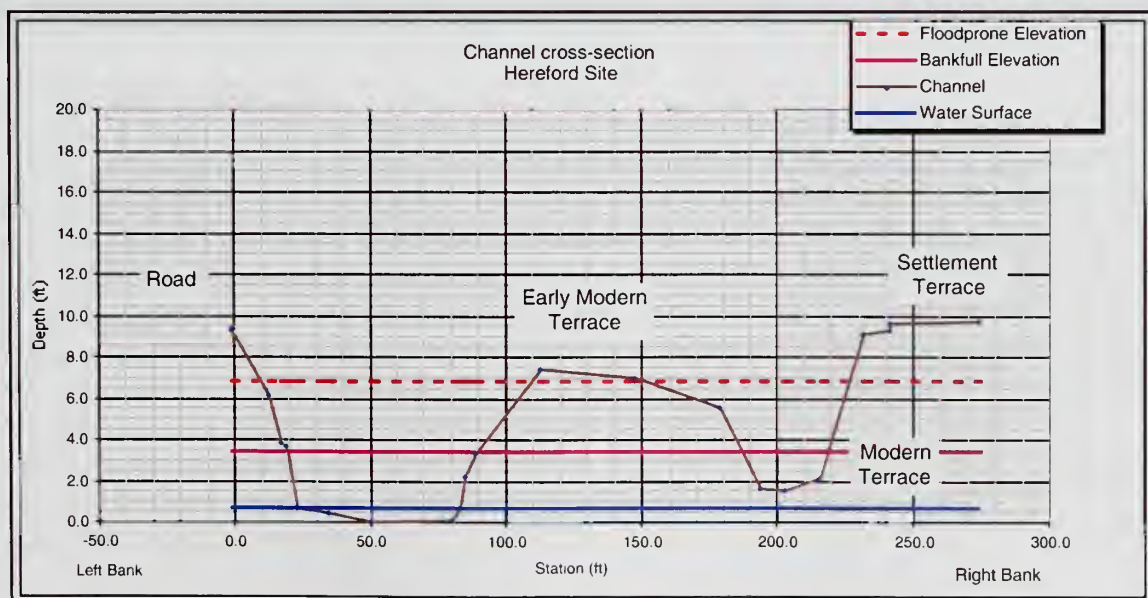
FIGURE 8a. Cross-section at Hereford survey site

Settlement Terrace (~1860 – 1890) lies approximately 10 feet above current channel bed elevation. Sands with bunch grasses and mature cottonwoods dominate the substrate. No young cottonwoods were observed on this terrace.

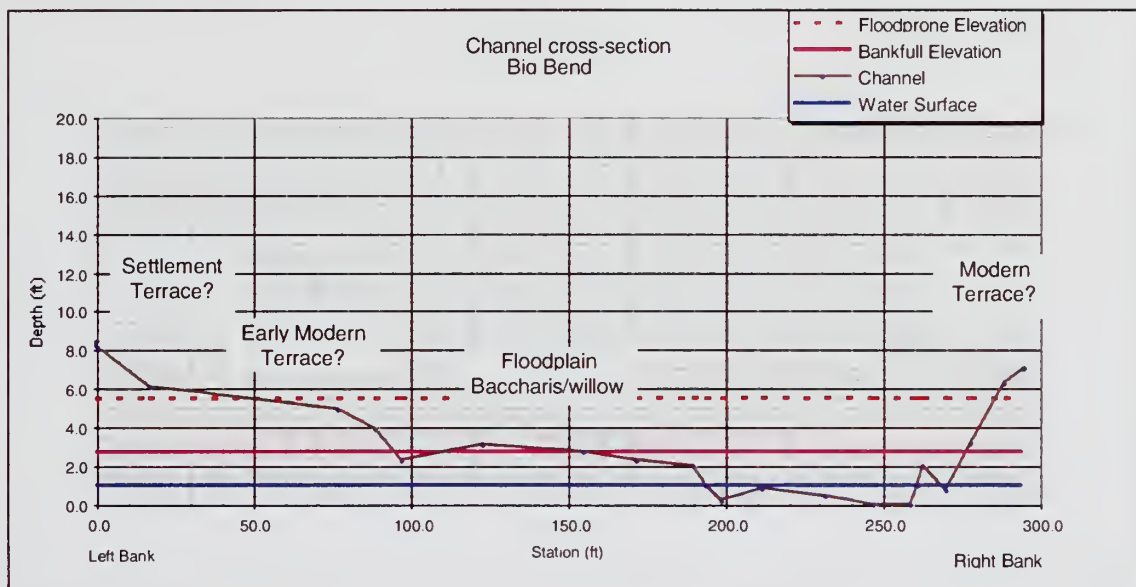
FIGURE 9b. Cross-section at Big Bend survey site

Big Bend survey site lies just upstream of the high viewpoint along the road just above Big Bend (Figure 9). The channel has a meandering riffle-run morphology with numerous low islands and cut-off channels. The combination of added sediment from eroding banks and split flow has formed a number of low unvegetated mid-channel bars.

There are several 10 - 20 feet tall ash and cottonwood trees established within the floodplains or in the abandoned or cutoff channels. Ash are usually more common. Hundreds of small seedlings (ash and cottonwood) were observed on low, moist sandbars located within the bankfull channel. However these have very little chance for survival. *Baccharis* dominated the low terraces or floodplains but willow as well as tamarisk was much more common in this reach. Several Cottonwood individuals 10 – 20 feet tall were observed along the floodplain and in abandoned channels.

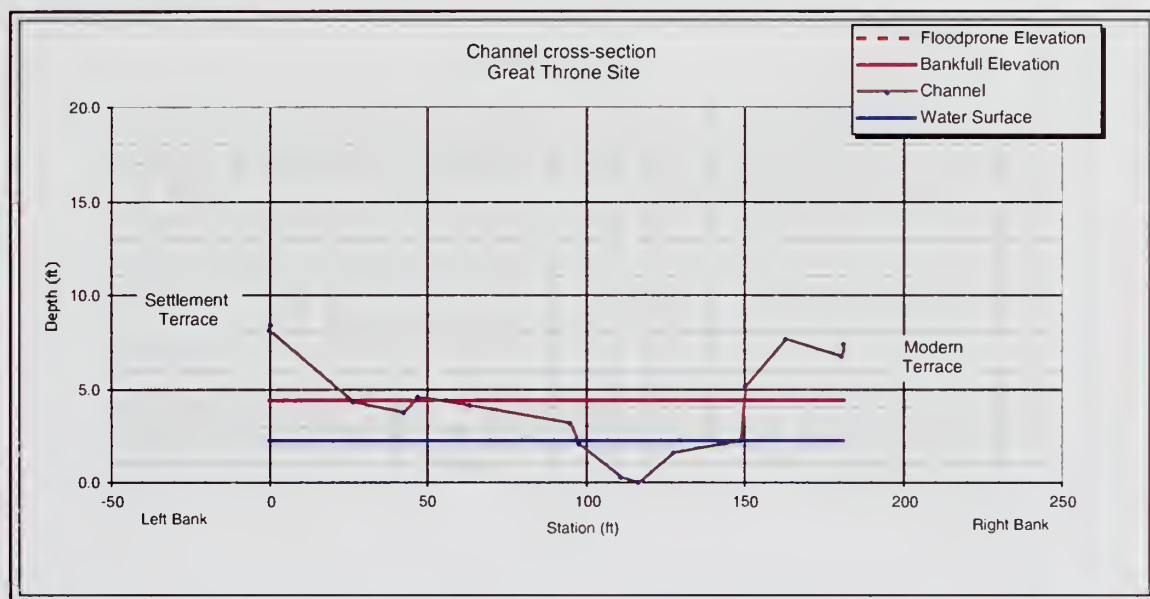
FIGURE 10. Cross-section at Great White Throne survey site

Great White Throne Site is located just downstream of Big Bend. This reach has considerable width to meander. There is very little incision with high terraces only 6 feet above streambed (Figure 10). Below the upstream revetments the channel makes a series of low flow meanders with low alternating point bars. The bars are freshly disturbed with a surface of sand over gravel/cobble. Young 1-year seedlings are very numerous within the active channel; cottonwoods, baccharis, tamarisk, and ash are present but obviously few survive. It appears that the river may not meander much at bankfull or above.

Low terraces on both sides of river contain a reasonable number of 10 – 25 feet tall ash, cottonwood, and tree willow. Coyote willow is also more abundant than at other sites. Low bars are often very wet and colonized by equisetum and sedges/rush. Arroyo willow (*Salix exigua*) is also more common. A survey of a single floodplain bar resulted in a count of 8-10 cottonwood, 25-30 ash, and 3-4 black willow. These individuals appear to be 5 – 10 years old. Recent beaver herbivory on cottonwoods and willows was observed at this site. Mature cottonwoods were abundant on the settlement terrace near the road.

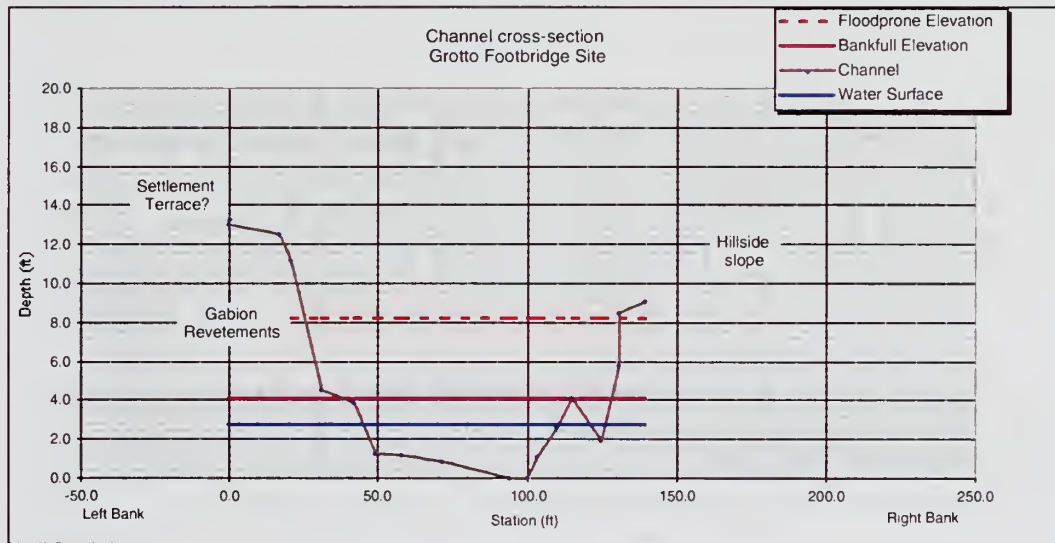
FIGURE 11a. Cross-section at Grotto footbridge survey site

This reach begins just above the Grotto Campground footbridge and extends through the stream section below the Lodge footbridge. The entire reach had been channelized and constrained by levees armored with wire covered rock riprap. In many areas the wire had deteriorated and the rock was falling into the channel. Channel is narrow with a uniform trapezoidal shape and no floodplain access. These reaches were zones of apparent and conspicuous regular scour and both the potential presence of moist and fine substrates for potential cottonwood invasion and cottonwood invasion were not observed.

Riprap baskets are reinforced around bridge but in other places rotted at the bottom with rock spilling out. High terrace is very flat and sandy with a widely scattered mature cottonwood forest. These were once leveled and utilized as cultivated and irrigated fields. A single representative cross-section was surveyed in this reach just below the Grotto Campground footbridge (Figure 11).

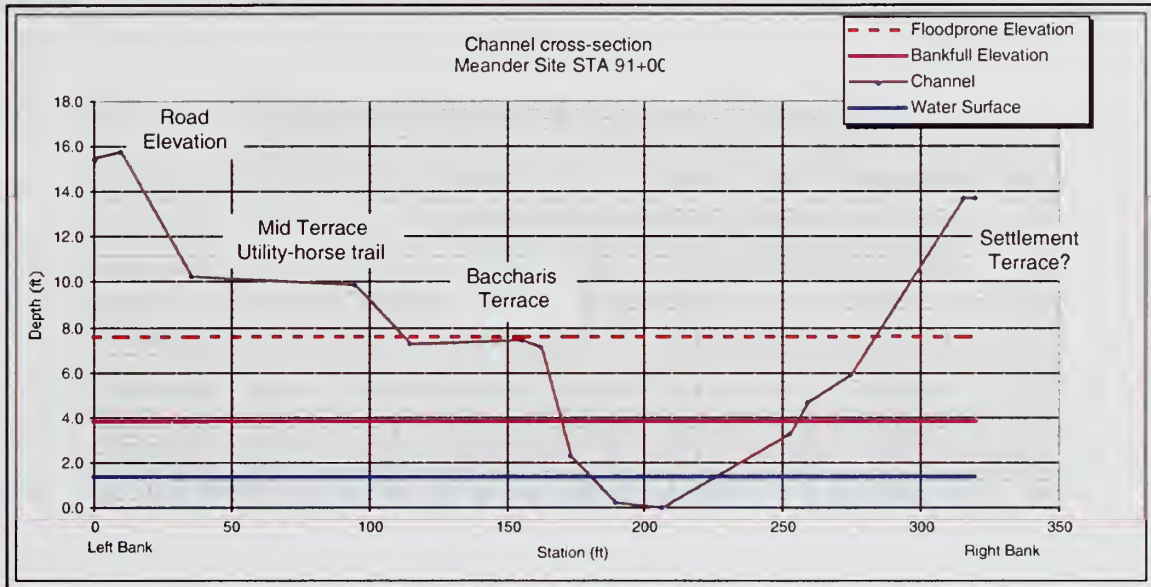
FIGURE 12b. Cross-section #1 in Birch Creek reach

This reach begins at the end of the straightened stream section about 1,500 feet below the Lodge foot bridges and extends to Birch Creek. Revetments are limited to the outside of those meanders that may impinge in the road or a parallel utility easement. From aerial photos it appears the stream has maintained its historic pattern, however it may have been channelized in the past. Channel and floodprone widths are similar to the sites Big Bend reach (Table 1). The width-depth ratios are somewhat lower and as a result sediment transport is greater. Point bars are well formed on the inside of each meander though most are 1 – 4 feet above bankfull stage (Figures 12b & 13). Active cutbanks are common along the outside of meanders and there is moderate disturbance on the outer edges of the point bars.

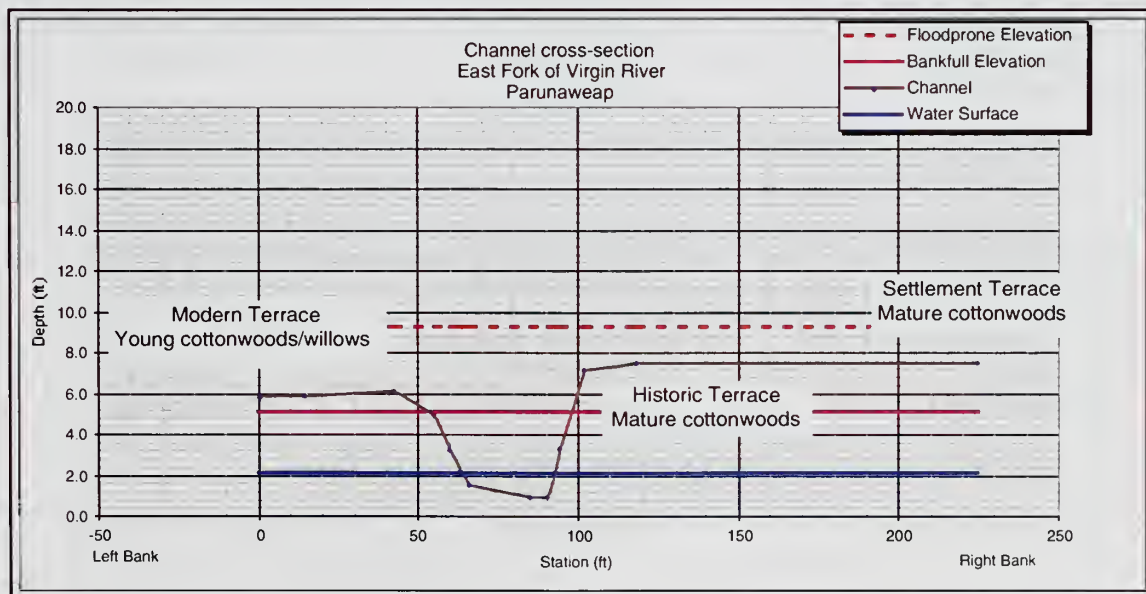
FIGURE 14. Cross-section at East Fork survey site

As in the North Fork, spare bunch grasses and very old cottonwood trees dominate high terraces. Mesquite occupies the terrace margins on south facing slopes. The Modern Terrace lies only slightly above floodplain elevation and contains a rich community of Arroyo or coyote willow (*Salix exigua*) and young Fremont cottonwood (*Populus fremontii*).
